BS-ISO helical gear fatigue life estimation and debris analysis validation

Abstract

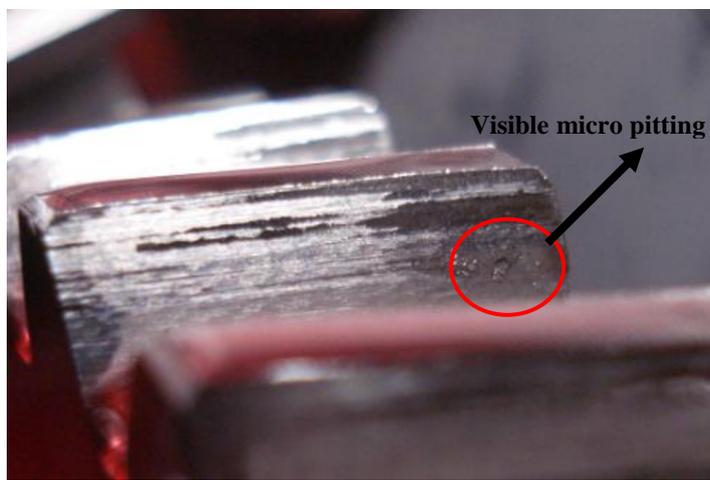
During first test at loading condition-1 visible micro pitting i.e. 5mm to 10 mm [7] was identified on 3rd visual inspection i.e. after 5.4×10^5 cycles of operation as shown in Fig 4. While for the second test at loading condition-2 the defined pitting was identified on 6th visual inspection i.e. after 1.08×10^6 cycles of operation as shown in Fig 5. In both tests, at test completion, more than 50% of driven gear teeth's were observed with micro pitting. In contrast to driven gears, driving gears were observed less pitted.

**Figure 4. Test-1 gear images showing pitting fatigue**
