Li Nan, Guogang Ren, Donghui Wang, and Ke Yang, 'Antibacterial Performance of Cu-Bearing Stainless Steel against *Staphylococcus aureus* and *Pseudomonas aeruginosa* in Whole Milk', *Journal of Materials Science & Technology*, Vol. 32 (5): 445-451, May 2016.

Antibacterial performance of a novel Cu-bearing stainless steel against *Staphylococcus aureus* and *Pseudomonas aeruginosa* in whole milk

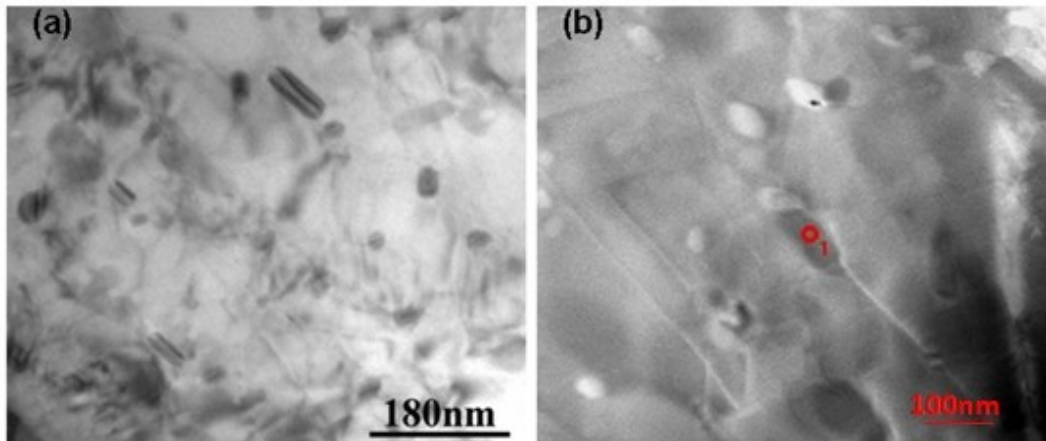
Fig. 1 Morphologies of the ϵ -Cu-rich precipitates in the 304CuSS steel aged at 973K for 6h, (a) Cu-rich precipitates shown as nano scaled particles (dark) and (b) HAADF image showing the ϵ -Cu rich nanoparticles (dark) of the precipitates.

Previous studies demonstrated that the existence of ϵ -Cu phase in the 304CuSS matrix provided strong antibacterial performance compared to 304SS (Nan et al., 2007). The observation using TEM revealed the morphologies of precipitates of the Cu nanoparticles or clusters were in a good conjugation with the stainless steel matrix in the present 304CuSS that was aged at 973 K for 6h as shown in Fig. 1. Accordingly these nano-scaled particles presented in Fig. 1 should be prevalingly the Cu-rich precipitates (Gagliano and Fine, 2004). These rod-like shape Cu-rich precipitates in 304CuSS showed their average size around 80 nm, (Fig. 1a). In order to confirm their Cu-rich precipitation prevalence in the steel matrix, further TEM examination was carried out and the result was shown in Fig. 1b, that an HAADF image proved the Cu-rich precipitates. Meanwhile, the corresponding composition analyses made by SEM-EDXS also confirmed the Cu-rich precipitation particles as listed in Table 2. The results illustrated that these particles within the matrix had higher concentration of copper element (19.6wt.%) in comparison of average matrix Cu content (3.8wt.%), The Cu elemental micro-structure in these Cu rich precipitates are identified to be in the form of ϵ -Cu.

Fig. 1 Morphologies of the Cu-rich precipitates in the steel aged at 973K for 6h, (a) Cu-rich precipitates and (b) HAADF image of the precipitates.

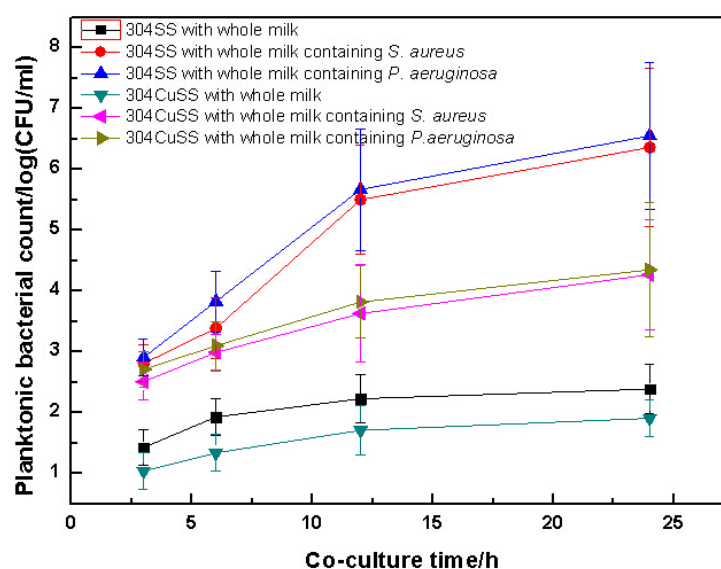
Fig. 2 Planktonic bacterial counts on surfaces of 304CuSS and 304SS samples exposure to the whole milk with and without bacteria for different time lengths.

Whole milk: The bacterial increment was over 9 times, as observed from the bacterial counts on plates and shown in Fig. 2. The growth of the number of planktonic bacteria after the milk contacted with the 304SS for 3, 6, 12 and 24h. A modest increase of bacteria was observed in the whole milk when contacted with the 304CuSS for 24h contact. After 24 h exposure to the milk, the inhibition rate of 304CuSS against the planktonic bacteria was from $59.2 \pm 1.3\%$ (3h) to $66.9 \pm 2.0\%$ (24h) in comparison with 304SS, indicating that the conventional stainless steel has no ability on inhibiting the bacterial growth in this medium.

Whole milk with *S. aureus*:, When the whole milk containing *S. aureus* contacted with steel samples, the number of planktonic bacteria increased much faster than that in the pure whole milk, as also shown in Fig. 2. Bacterial colonies increased between 2.51 ± 0.3 log (CFU/ml) and 4.27 ± 0.9 log (CFU/ml) after contact with 304CuSS from 3h to 24h. There were more colonies on 304SS between 2.81 ± 0.3 log (CFU/ml) and 6.36 ± 1.3 log (CFU/ml) after contact with bacterial for the same periods. The bacteria was allowed much more easily to be survived and propagated after the whole milk contacted with 304SS, and in contrast, the antibacterial rate of 304CuSS reached

The increment of planktonic bacteria count was 43 times for 304SS and the bacteria reached to 6.55 ± 1.2 log (CFU/ml) in 24h). By contrary, only 4.35 ± 1.1 log (CFU/ml) of bacteria appeared on the 304CuSS, and its inhibition rate against the planktonic bacteria in the milk medium was 99.3%. Therefore, it can be concluded that 304CuSS shows a better antibacterial performance against planktonic bacteria in the whole milk with and without bacteria in comparison to 304SS, which can significantly lower the risk of bacterial bio-contamination.

Fig. 2 Planktonic bacterial counts on surfaces of steel samples after contacted with the mediums for different times.

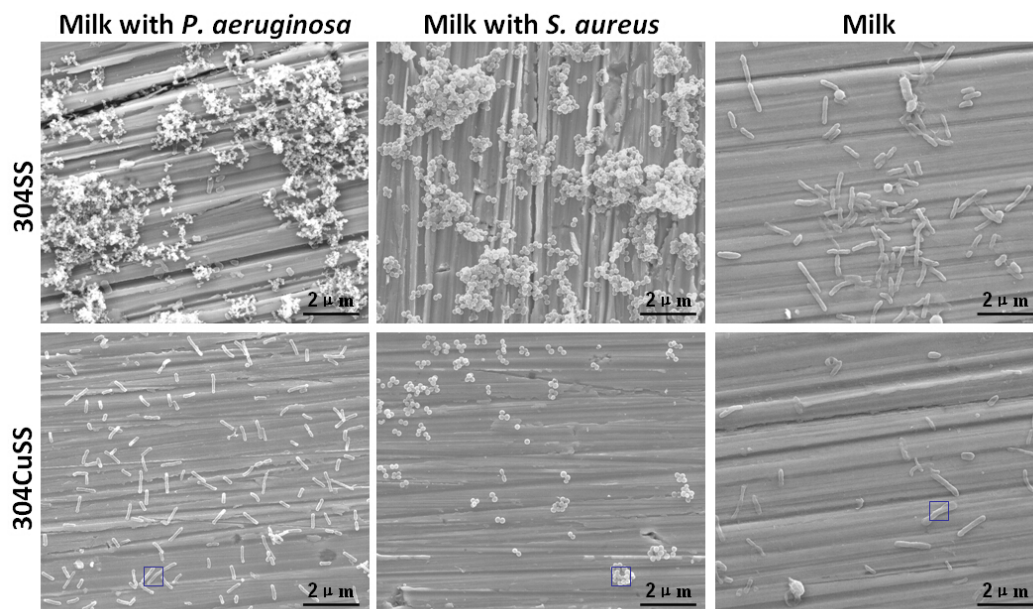
Fig. 3 Morphologies of bacteria in milk after contact with steel samples for 24h.

Morphologies of sessile bacteria in the whole milk with and without bacteria after contact with steel samples for 24h are shown in Fig. 3. The results show that after contact with steel samples, not only single sessile bacterium but also clustered ones in the form of biofilms appeared on the surfaces of 304SS, while only a few scattered ones observed on the 304CuSS surface, indicating that the sessile bacteria were much easier adhesive to 304SS than to 304CuSS. In addition, it is observed from Fig. 3 that the island-like thick biofilms were found on the 304SS steel surfaces after contacted with the whole milk containing bacteria, while only long rod-like and thin clusters appeared on the same steel substrates exposed in the milk without bacteria. The morphology results demonstrated that once the whole milk was contaminated with bacteria, the bacteria were developed into the biofilms and not easily to be removed from the 304SS surfaces. Meanwhile as a contrast, the chemical compositions of the

304CuSS surfaces after contacting with different mediums for 24h are listed in Table 3. Certain amount of Cu concentration on the stainless steel surface demonstrated that the exposure of the 304CuSS to different mediums would guarantee the release of Cu^{2+} into the surrounding environments.

Fig. 3 Morphologies of bacteria in drinks after contact with steel samples for 24h.

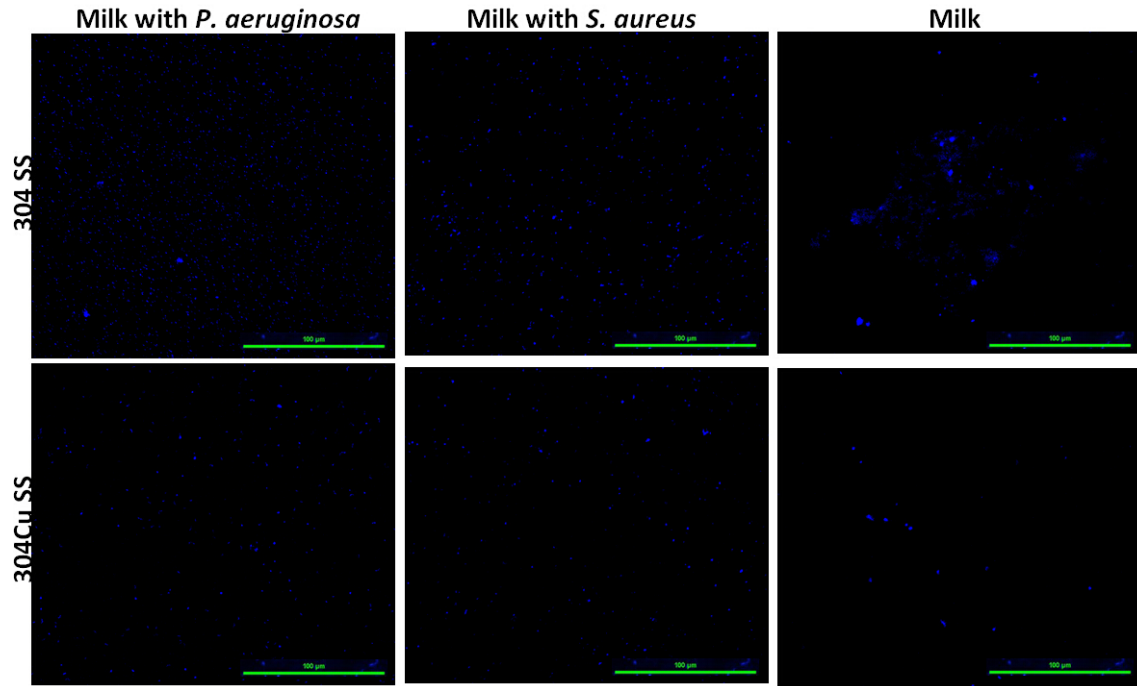
Fig. 4 Images of bacteria in drinks stained with DAPI under epifluorescence microscopy after contact with 304SS and 304CuSS samples for 24h, magnification $\times 40$.

Live sessile bacteria on the steel surfaces were also observed by DAPI staining under epifluorescence microscopy, as shown in Fig. 4. A series of images of bacterial adhesion on the steel samples presented different functions of 304CuSS and 304SS after 24h contacts with the whole milk with and without bacteria. The images show the variations of sessile bacteria growth after contact with steel samples in terms of different solutions, while the number of sessile bacteria spots was also much varied, indicating a dynamic activity process in bacteria formation and succession on two types of steel samples. As shown in Fig. 4, a large amount of live sessile creatures were accumulated and clustered on the 304SS surface, while by contrary, only a few of scattered ones were observed on the 304CuSS surface.

Bacterial adhesion is a physicochemical phenomenon controlled by properties of the receptive surface, the liquid medium and the microorganism (Meylheuca et al., 2006). Once the biofilms are adsorbed (attached/adhered) on material surfaces, they are hard to be removed in which a series of problems can be easily brought about to cause a serious food contamination and safety issue. Especially, the extracellular polymeric substances (EPS) can gradually grow with a metabolism proceeding, as being generally considered vital in cementing bacterial cells together to form the biofilm structure (Stoodley et al., 2002). In this study, the number of sessile bacteria on the 304CuSS was far fewer than that on the 304SS, as shown in Fig. 4, reasonably indicating that less EPSs existed on the 304CuSS surface.

Fig. 4 Images of bacteria in drinks stained with DAPI under epifluorescence microscopy after contact with steel samples for 24h, magnification $\times 40$.

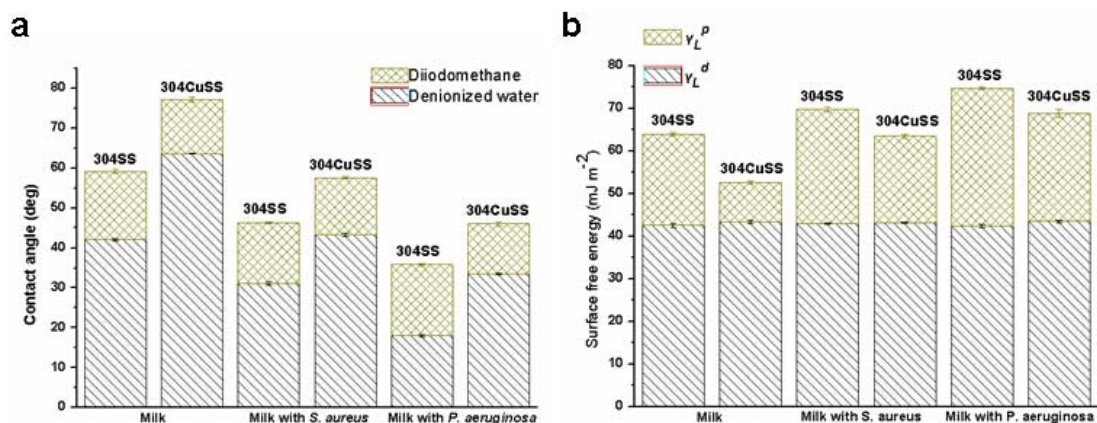
Fig. 5 Surface analyses of stainless steel samples after contact with different bacteria in the whole milk for 24h, (a) contact angle; (b) surface free energy (SFE).

more prevalent compared to diiodomethane. The relevant polar component showed the obvious function for the surface free energy (SFE) calculation, as shown in Fig. 5(b). After contact with the whole milk for 24h a large difference on SFE was presented between two steels, the mean value of SFE ($63.9 \pm 0.08 \text{ mJ} \cdot \text{m}^{-2}$) for 304SS was obviously higher than that of 304CuSS ($52.6 \pm 0.12 \text{ mJ} \cdot \text{m}^{-2}$).

As shown in Fig. 5 Fresh milk contains relatively fewer bacteria, but contamination during handling can rapidly multiply the bacterial numbers. Multi-species microorganisms, such as *Escherichia coli*, *Pseudomonas*, *Staphylococci* and *Bacillus cereus* are normally present in milk (Rendueles and Ghigo, 2012), which can cause the deterioration of milk, and even possibly lead to cross-contaminations to

Fig. 5 Surface analyses of steel samples after contact with different drinks for 24h, (a) contact angle; (b) Surface free energy (SFE).
